Inspection Report

Property Address:
123 Main St
Scottsdale az 85255

Checklist Inspections

Date: 10/1/2016	Time:	Report ID: 20160913b
Property: 123 Main St Scottsdale az 85255	Customer: John Doe Jane Doe	Real Estate Professional:

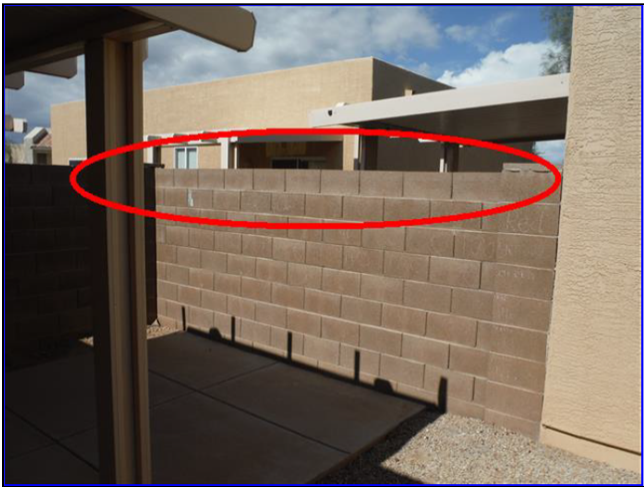
1.2 Item 1(Picture)

(3) Several masonry bricks on the top course of the masonry fence is not secure and needs to be reset. This was noted at left rear wall.

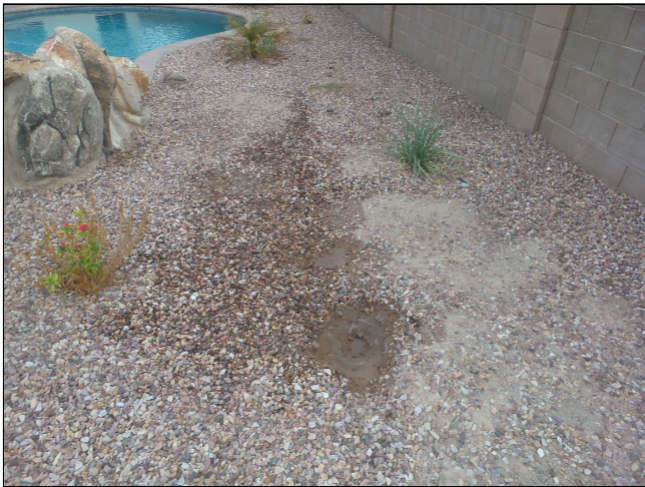
1.3 Item 1(Picture)

(1) Though irrigation sprinkler systems are not a required item for inspection, Checklist Inspections reviews system when possible. A majority of the sprinkler system is not visible.

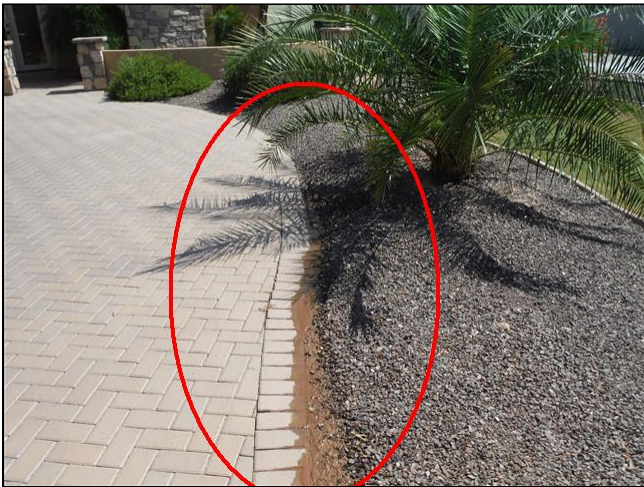
1.3 Item 2(Picture)

(2) Flooding in ground when irrigation system is on. Sign of a cracked or broken distribution line. Recommend correction.

Noted at right rear of home and right of front driveway.

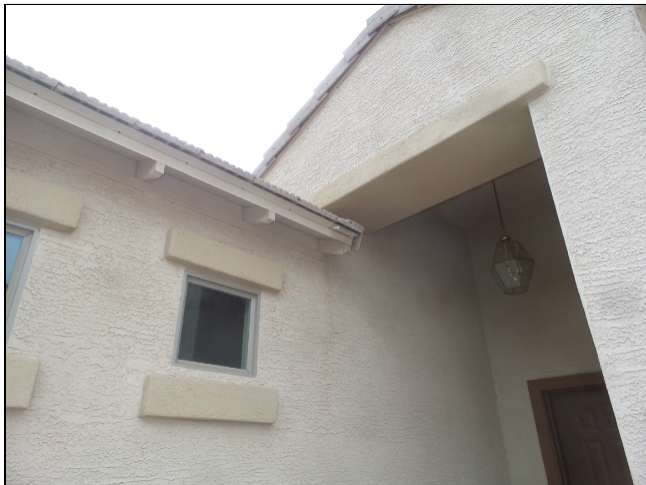
2.0 Item 1(Picture)

(1) Water staining under eaves. This is a sign that the underlayment is in need of repairs. Recommend correction by a licensed roofing contractor.

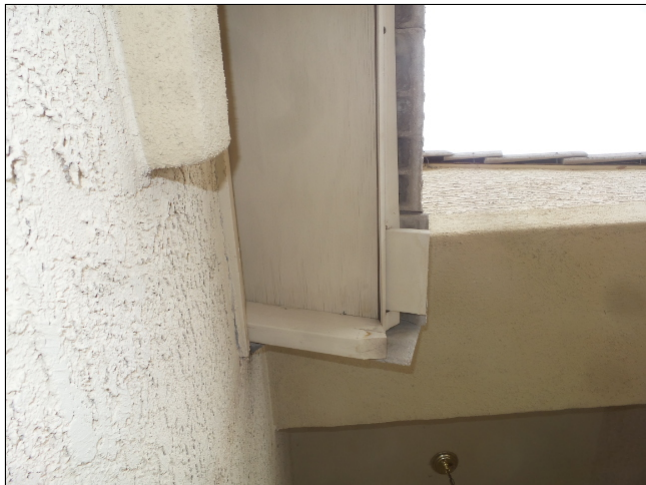
2.0 Item 2(Picture)

(2) Debris noted at roof. Recommend removal on a bi-annual basis.
-

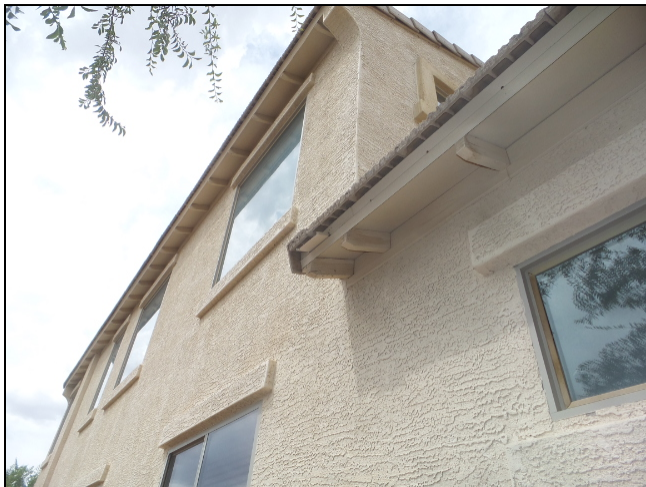
2.0 Item 3(Picture)

(3) Several of the roof tiles at the hip ridges are out of position, and need to be set back and secured. Recommend correction by a licensed roofing contractor.

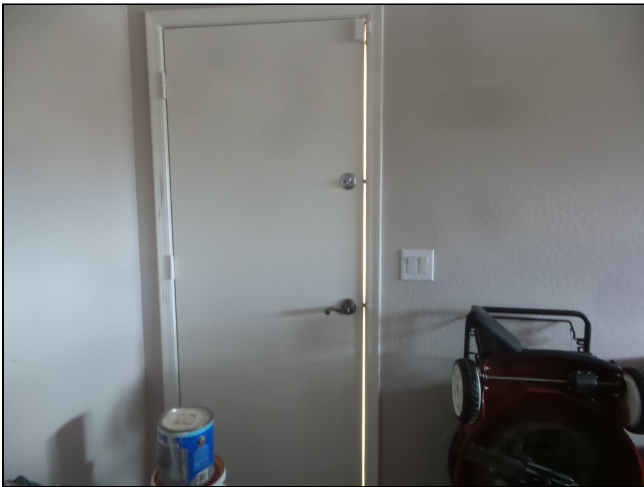
2.2 Item 1(Picture)

The door is allowing an excessive amount of light around jamb. Recommend correction. Noted garage access door

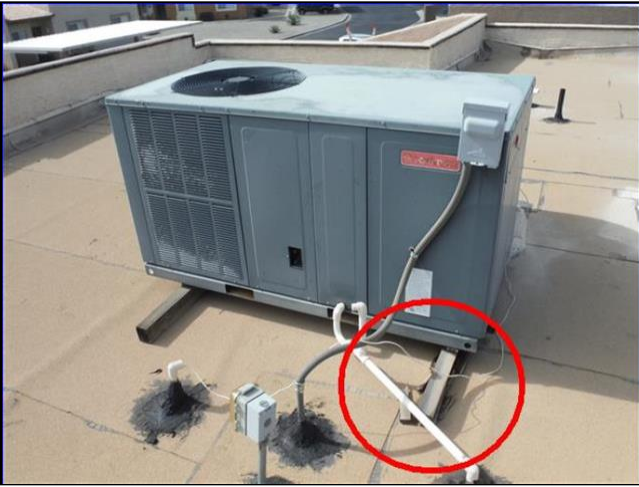
3.0 Item 1(Picture)

- (1) Wood stand at roof mounted HVAC unit is damaged / dry rot. Recommend correction.
- (2) The Delta-Ts (temperature splits) for the cooling mode of the HVAC system were acceptable. (between 18-22 degrees)

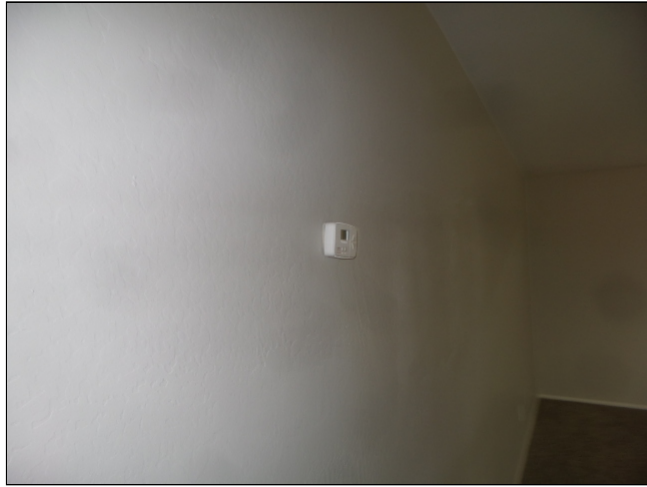
3.1 Item 1(Picture)

- Thermostat loose on wall. Recommend correction. Noted that both units

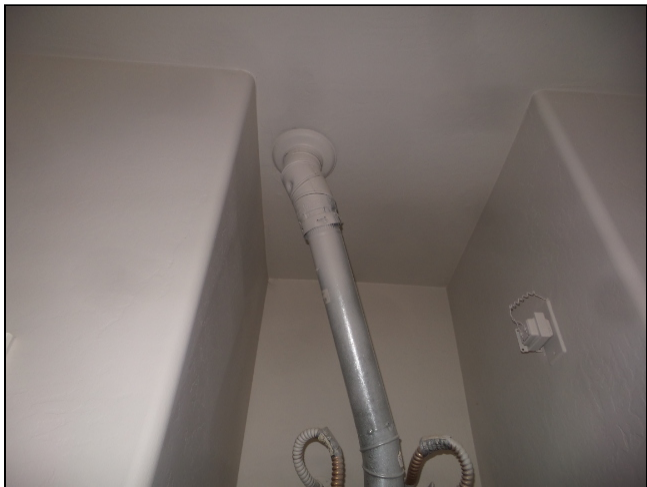
4.0 Item 1(Picture)

(1) The vent for the water heater should not be painted. The paint can burn / become discolored and possibly "smoke". Recommend to replace water heater vent.
-

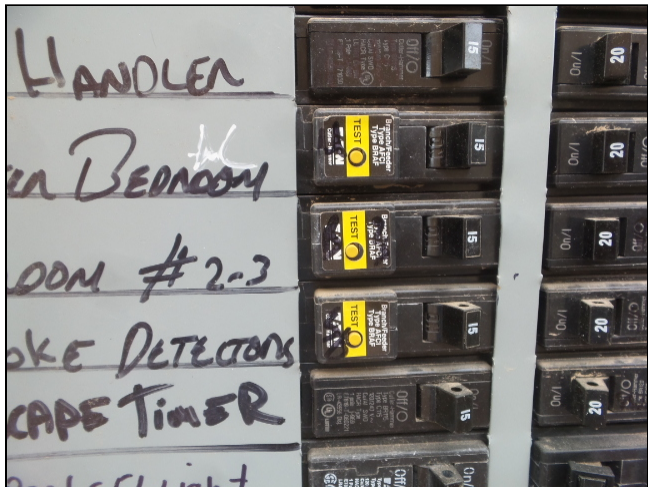
5.0 Item 1(Picture)

Arc-Fault breaker did not function / trip when tested. Recommend replace arc-fault breaker.

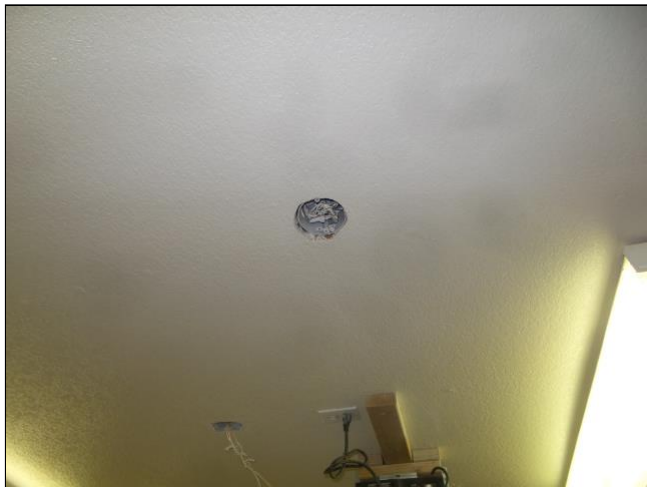
5.1 Item 1(Picture)

(2) Fixture (such as light or fan) removed. Recommend to cover wires or replace fixture.
Noted at garage ceiling.

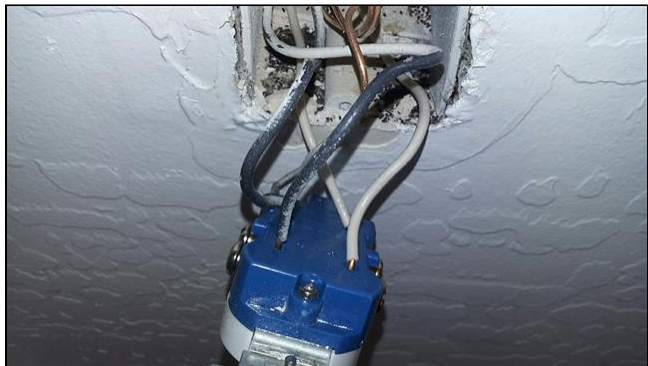
5.2 Item 1(Picture)

Receptacle is loose / pulled from wall. Recommend correction. Noted in master bedroom.

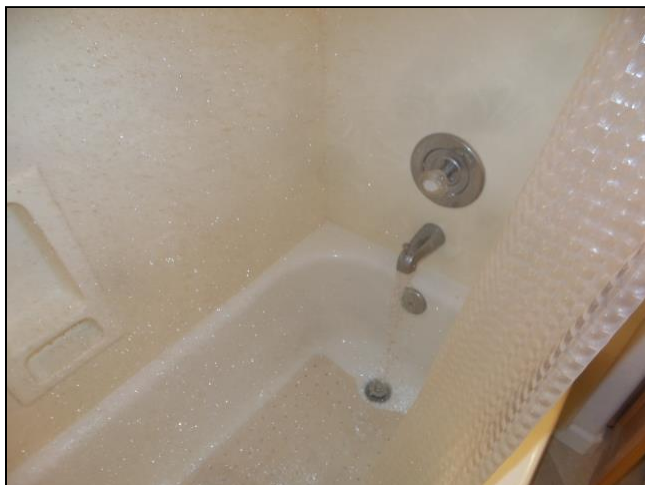
6.0 Item 1(Picture)

The diverter valve leaks a large amount of water from spout when shower is on. Recommend correction. Noted in hall bathroom.

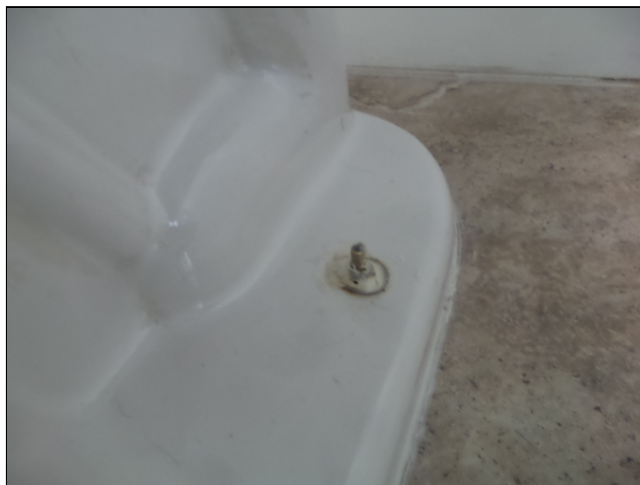
6.2 Item 1(Picture)

(1) Recommend to trim bolt as needed and install bolt caps. Noted in half bath.

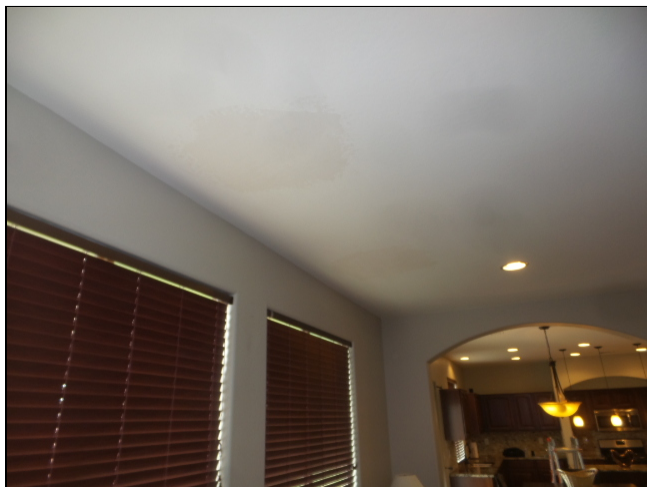
7.0 Item 1(Picture)

(1) Signs of past ceiling repair. Recommend to inquire with owner as to any past leak and repair history, and correct as needed. Noted in living room.

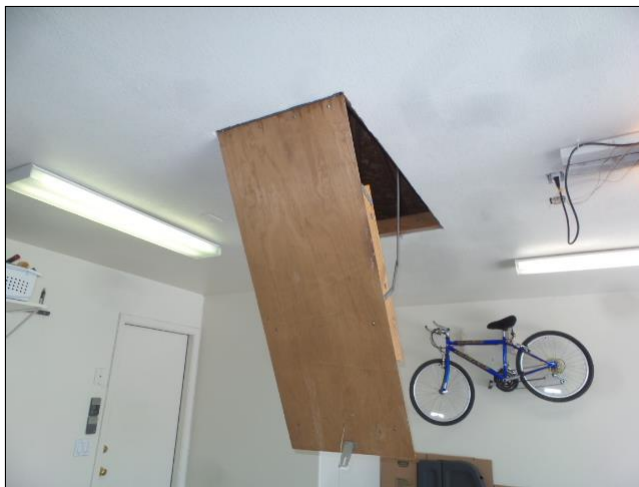
7.0 Item 2(Picture)

(3) The pull down ladder in the garage negates the draft stop in the garage. This can be repaired in place by adding a sheet of 26 gauge sheet metal to the ladder cover.

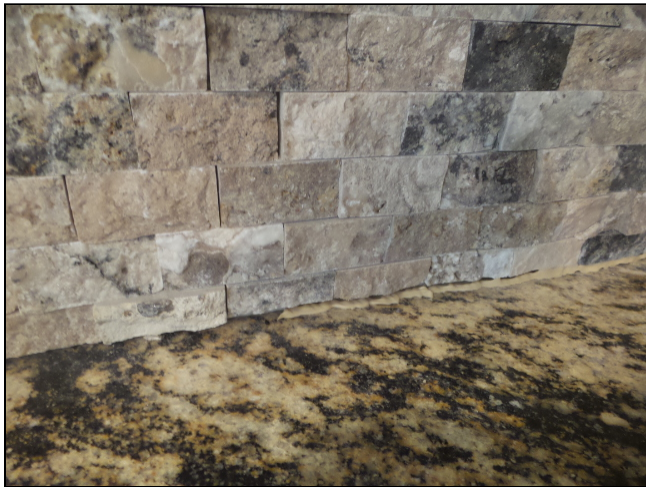
8.2 Item 1(Picture)

grout missing

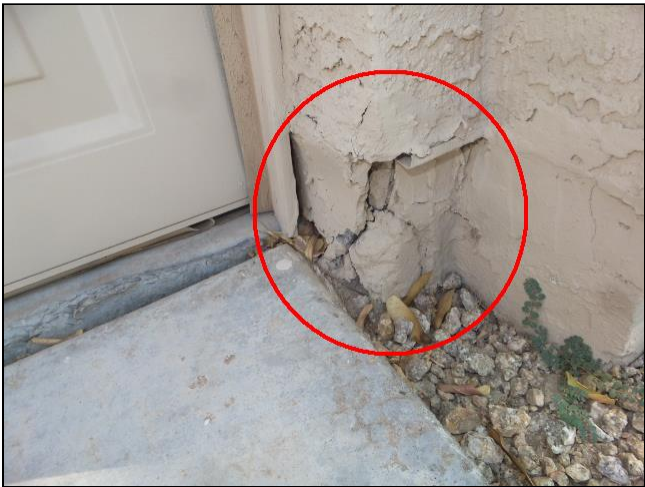
9.0 Item 1(Picture)

(3) Cracking of the stem wall due to expansion of a tie down. Recommend to clean loose debris, prime exposed metal (if noted), and patch area with an appropriate cement patching compound.
Noted at right corner of single car garage.
